## SMALL CRATER EXPEDIENT REPAIR TEST

KENNETH J. KNOX  
ENGINEERING RESEARCH DIVISION

AUGUST 1980

FINAL REPORT  
JULY 1979 — AUGUST 1979

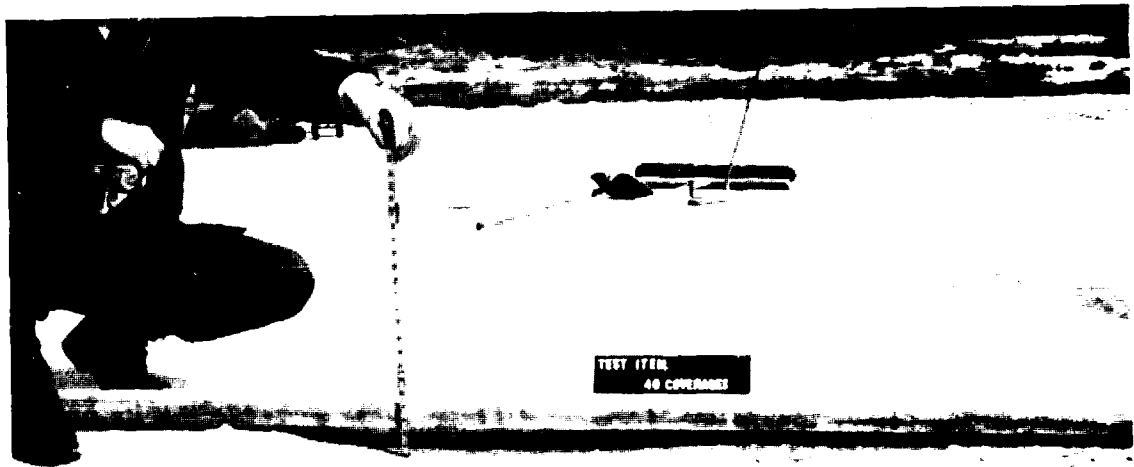
Figure 11. Consolidation of Crushed Limestone at Edge of Concrete

The crushed stone should not exceed one inch in height above the adjacent concrete or extend below the adjacent concrete by two inches. Careful attention must also be given to the joint between the crushed stone and the existing concrete such that the crushed stone never falls one-half inch below the level of the concrete creating a sharp bump which might damage the aircraft (Figure 11). If the crushed stone compacts below one-half inch at the concrete joint, additional material should be added and compacted.

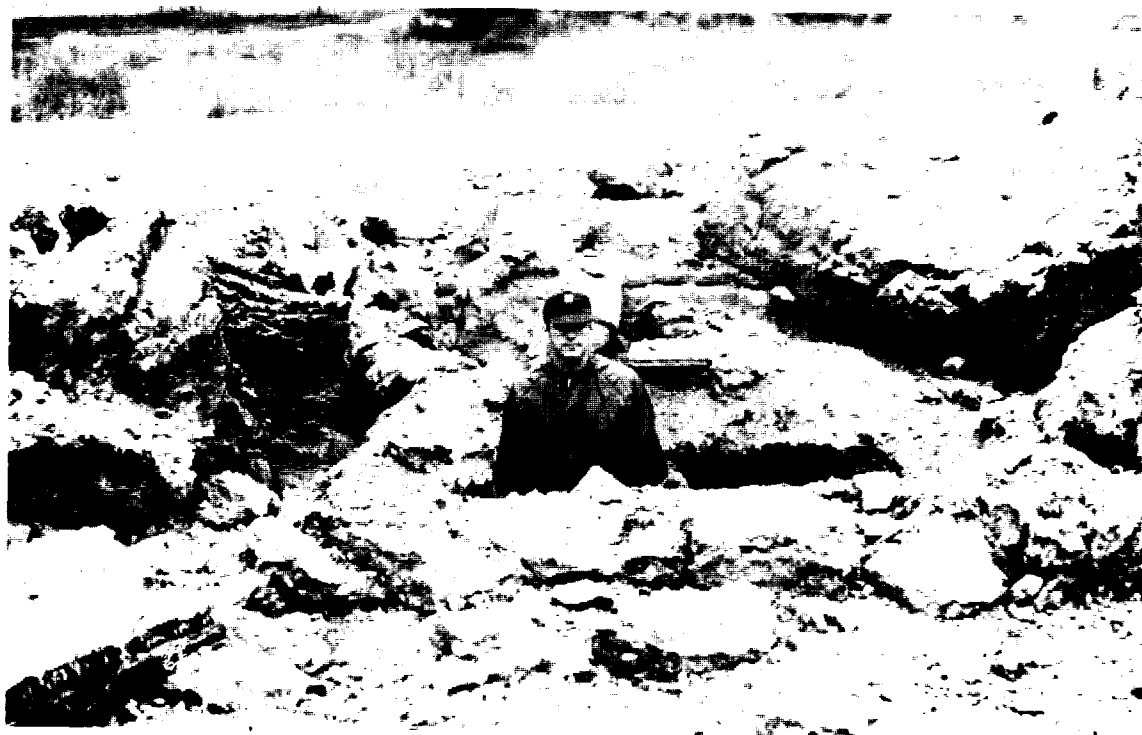
Figure 18. Crater 1

The repair team backfilled the crater with debris to approximately 12 to 15 inches below the pavement surface. The

plan was to build a working platform with crushed limestone on top of the clay backfill, and then compact the clay using the loader tires to the required 24-inch depth as shown in Figure 21. However, the clay failed to significantly compact under the loader tire loads. This resulted in a debris backfill that was approximately 15 inches from the surface and poorly compacted. The repair team OIC reported seeing voids in the backfill as a result of insufficient compaction of the clay chunks.

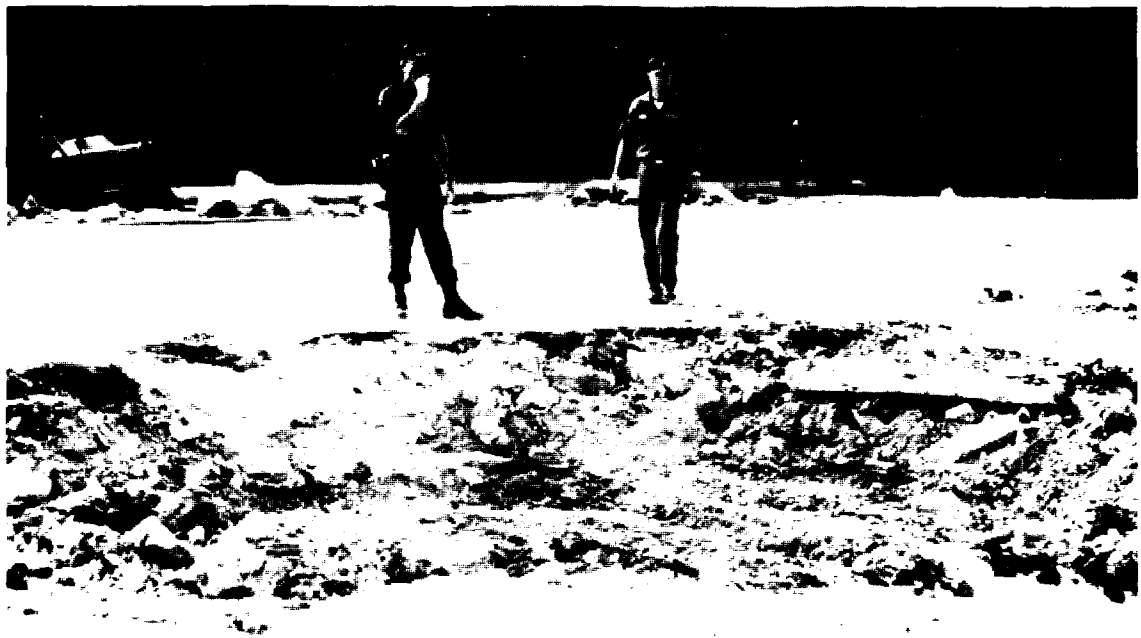
Figure 29. Crater 3 After Clearing of Debris

Crater 3, located in the asphalt portion of the test pad, was a timed repair using the crushed limestone method. As can be seen in Figure 29, Crater 3 had a significant amount of fallback. This resulted in a rather shallow crater that required deepening and careful compaction. The repair team's instructions were slightly modified to permit more than 24 inches of crushed limestone. This allowed the repair team OIC to determine the best approach to handling the debris backfill. Figures 30 and 31 graphically show the sequence of events and the equipment usage for Crater 3.

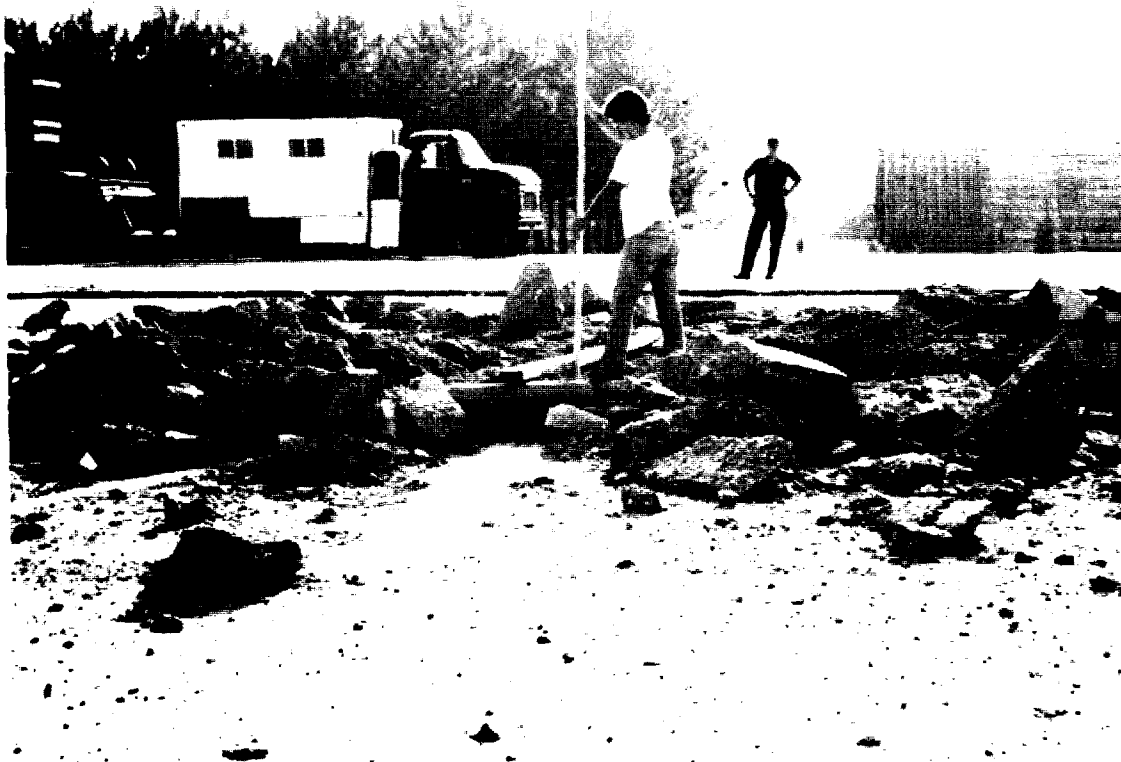
Figure 38. Crater 2

The second crater test performed during the Small Crater Test was a practice repair using polymer-concrete. As in Crater 1 the repair team was briefed on repair procedures and told to emphasize repair quality over time. Crater 2 was a relatively shallow crater with a large amount of fallback material, as shown in Figure 38.

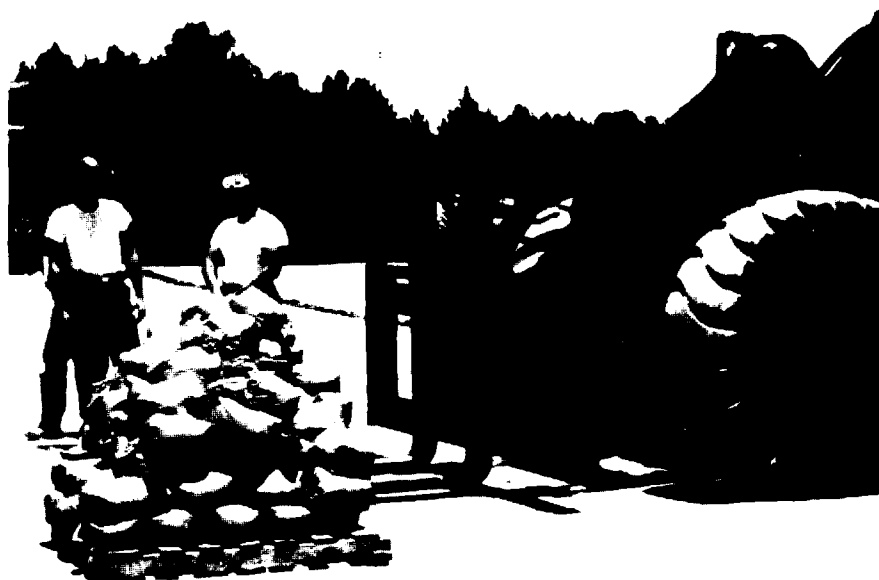
Figure 44. Pallet of Silikal®

While the crater edges were being cleaned, the forklift began unloading the pallets of polymer material from the lowboy. As can be seen in Figure 44, the bags of Silikal® polymer-mortar were stacked unbound on the pallets. This presented a problem to the forklift operator, as bags of the powder kept falling off the pallet during handling. An improved packaging method would be required if this type of repair is adopted for use by the Air Force.

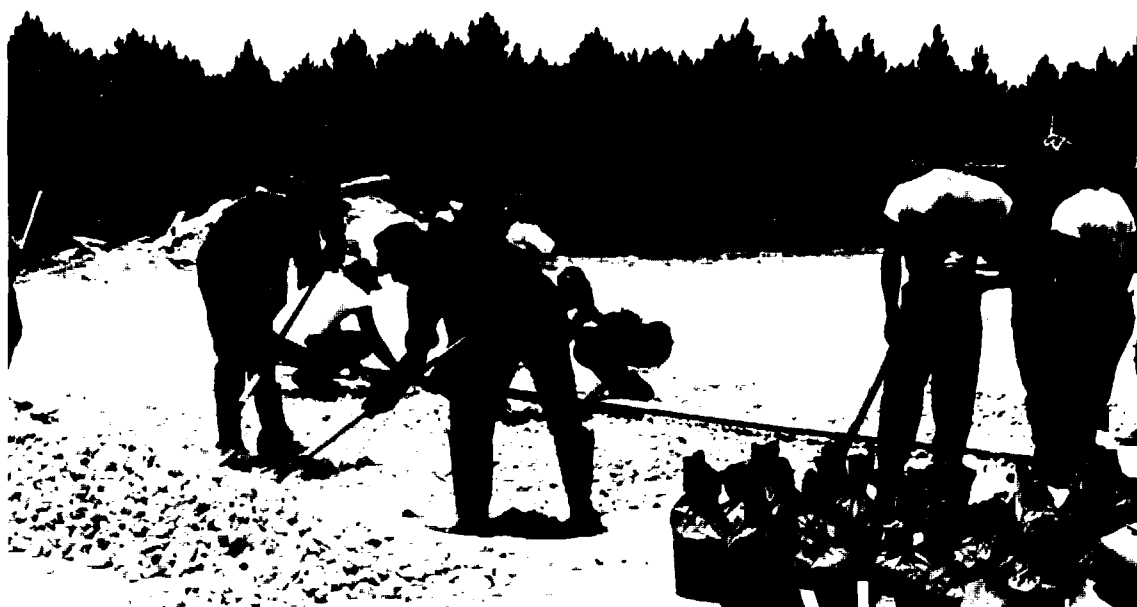
After the crater edges had been cleaned, the two-inch uniform aggregate was dumped into the crater and leveled. The leveling of the uniform aggregate proved very difficult due to its tendency to roll and shove inside the crater. The grader operator was unable to satisfactorily level the stone (partially due to inexperience), and the repair team was finally forced to use a screed beam and shovels to obtain the final grade, as shown in Figure 45. Leveling of the uniform aggregate required 27 minutes to complete.

Figure 45. Leveling the Uniform Aggregate by Hand

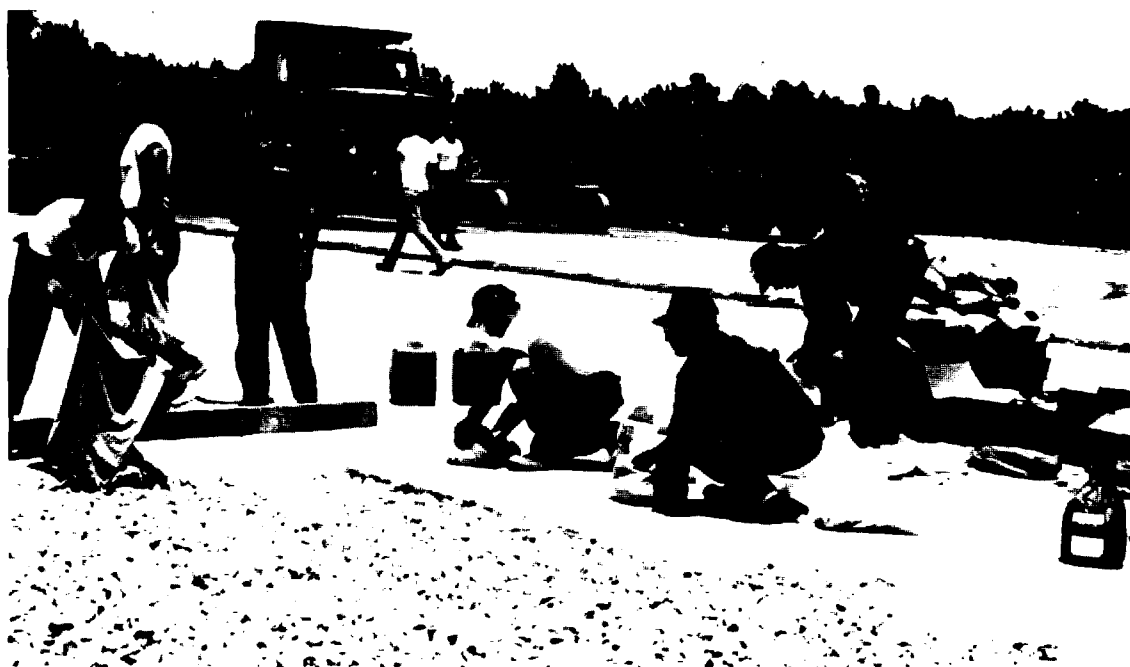
After the uniform aggregate was in place, the mixing and placing of the polymer-mortar was begun, as shown in Figure 46. During this phase the repair team was required to use eye goggles and rubber gloves for protection from the toxic chemicals. Fire extinguishers were placed nearby and smoking was prohibited, as the liquid component is a Class I flammable material.

Figure 46. Mixing and Placing the Polymer-Mortar

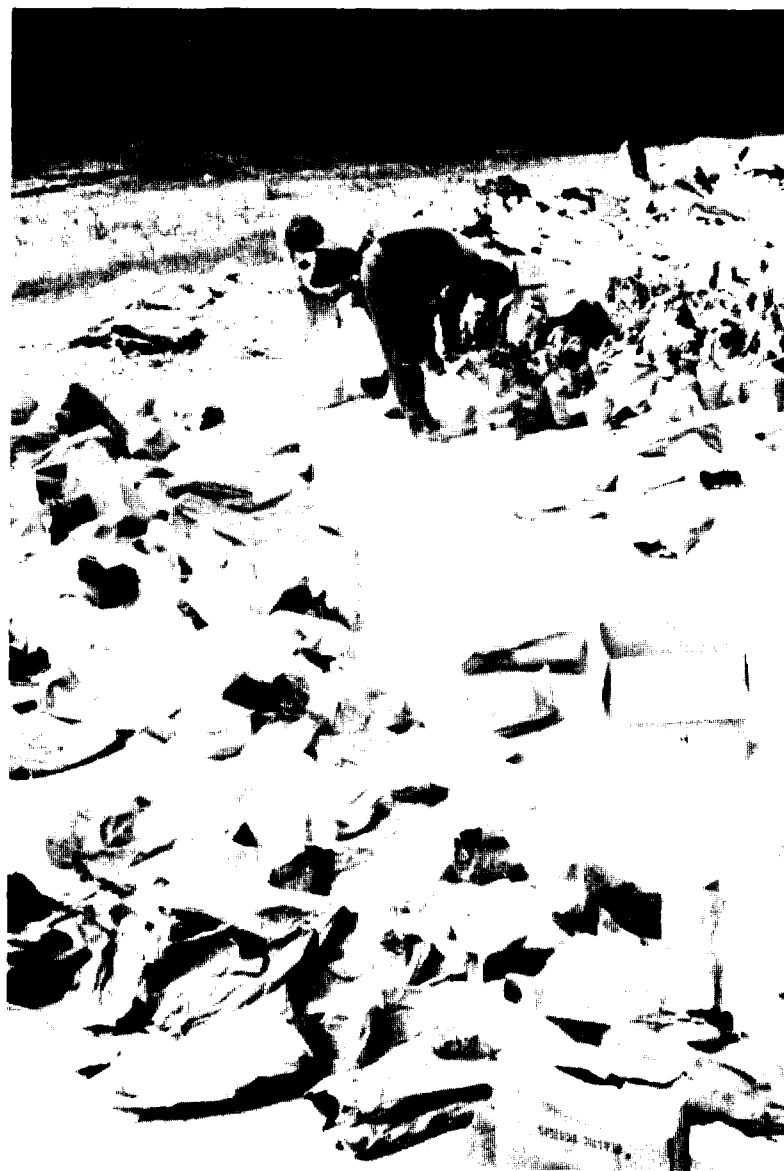
The polymer-concrete was allowed to cure for 43 minutes following placement. During this time the tired repair team cleared the crater area of the extensive debris caused by the bags of polymer-mortar (Figure 48). The entire repair required 4 hours 5 minutes (245 minutes) to complete.

Figure 48. Debris From Polymer-Concrete Repair

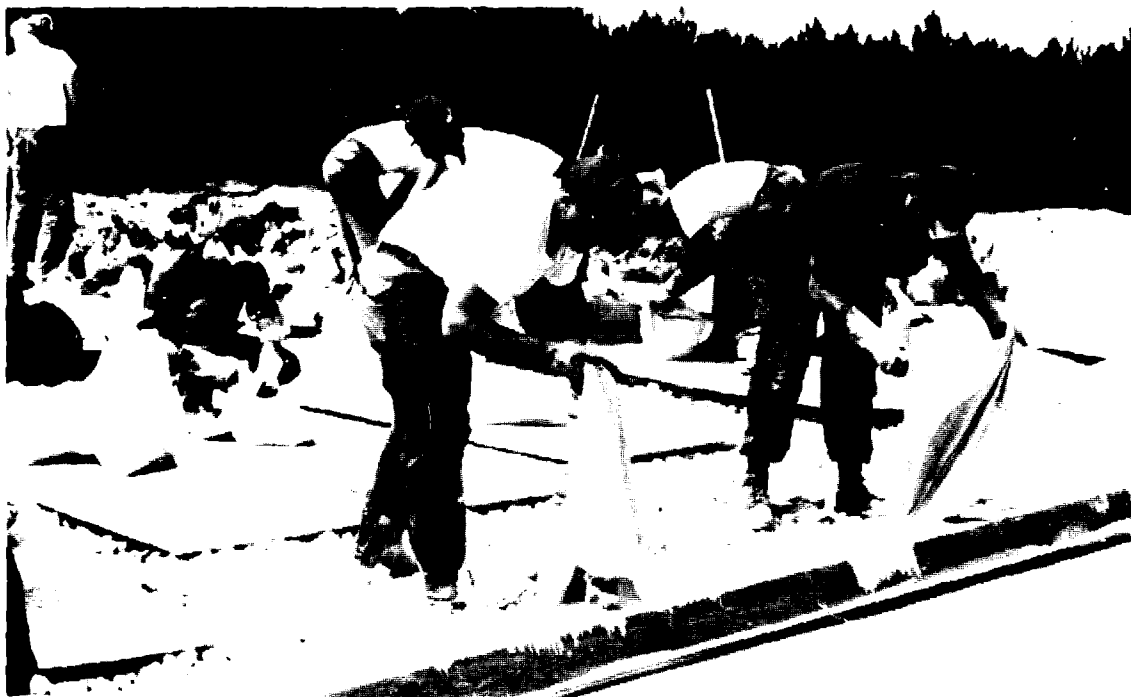
The next activity in the repair was the mixing and placing of polymer-mortar. In an attempt to facilitate this activity, the 13-man repair team was augmented with two additional men. The 15-man team was organized into five two-man teams, two screeders, a supervisor (OIC), and two utility men whose job was to keep the teams supplied with bags of polymer-mortar. Each two-man team was given a work station along the width of the repair. This organization is shown in operation in Figure 52.

The screeding operation was still a problem for the repair team due to mortar caking on the screed. Approximately half-way through the pouring operation, the screed was replaced with a new one. This, along with insuring that the screeding operation kept up with the pouring of the Silikal®, resulted in a much improved surface finish over that achieved in the Crater 2 repair.

Fig. 52. Two-man Teams Mixing and Placing Silikal®

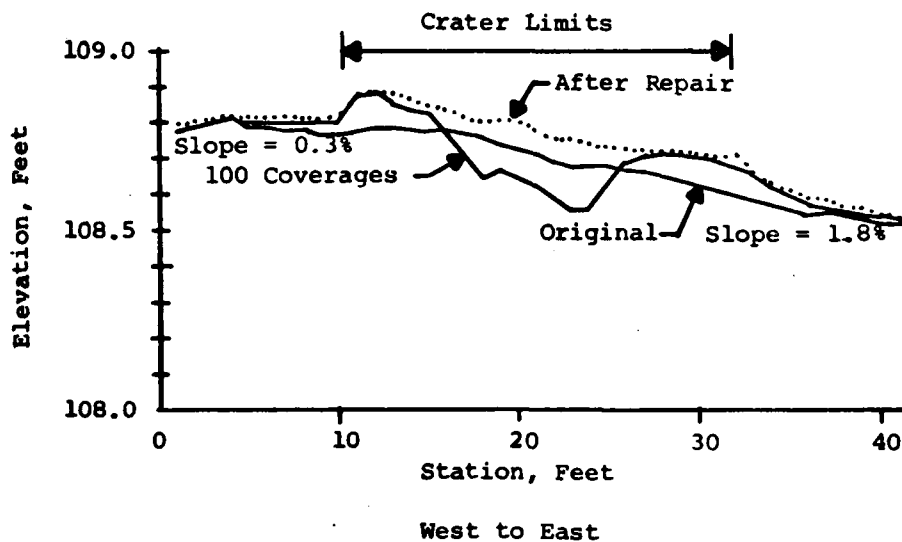
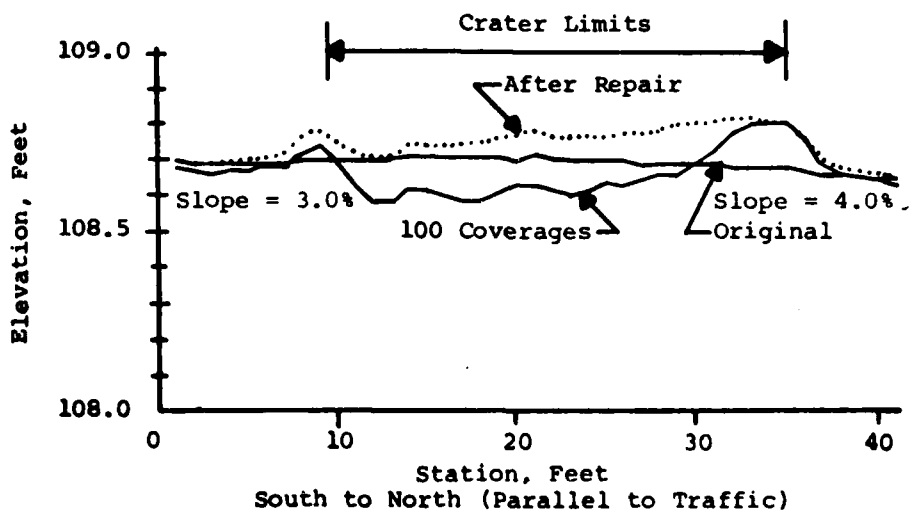
**Figure 58. Crater 3 Profiles (Before Maintenance)**

**After Repair:** Maximum Upheaval = 1.4"      100 Coverages: Maximum Upheaval = 1.3"  
Maximum Sag = 0.7"      Maximum Sag = 2.6"

**After Repair:** Maximum Upheaval = 1.7"      100 Coverages: Maximum Upheaval = 1.5"  
Maximum Sag = 1.0"      Maximum Sag = 2.2"

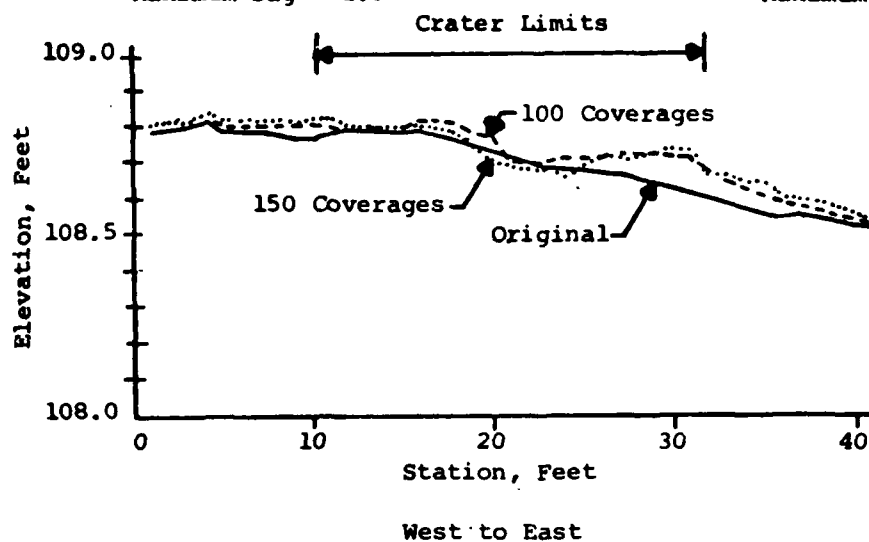
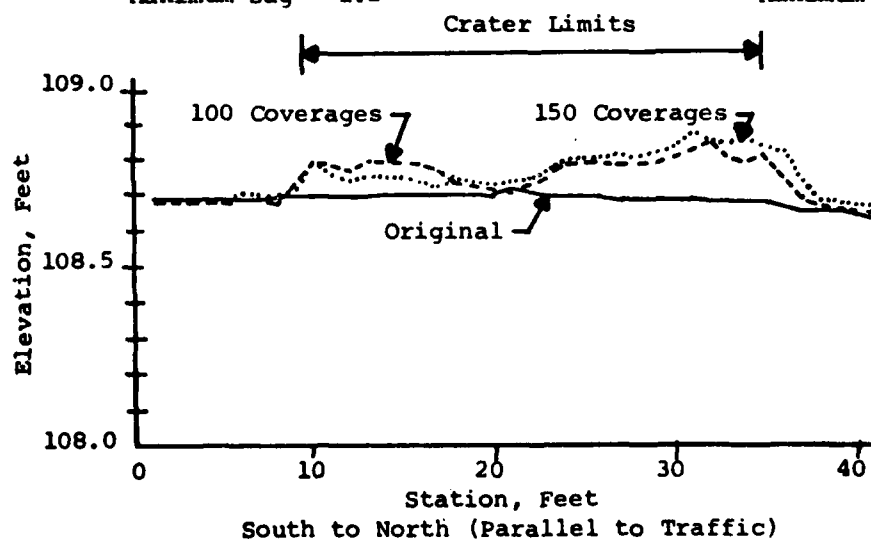
**Figure 59. Crater 3 Profiles (After Maintenance)**

100 Coverages: Maximum Upheaval = 1.3"      150 Coverages: Maximum Upheaval = 1.4"  
Maximum Sag = 1.0"      Maximum Sag = 1.3"

100 Coverages: Maximum Upheaval = 2.0"      150 Coverages: Maximum Upheaval = 2.3"  
Maximum Sag = 1.2"                                      Maximum Sag = 1.3"

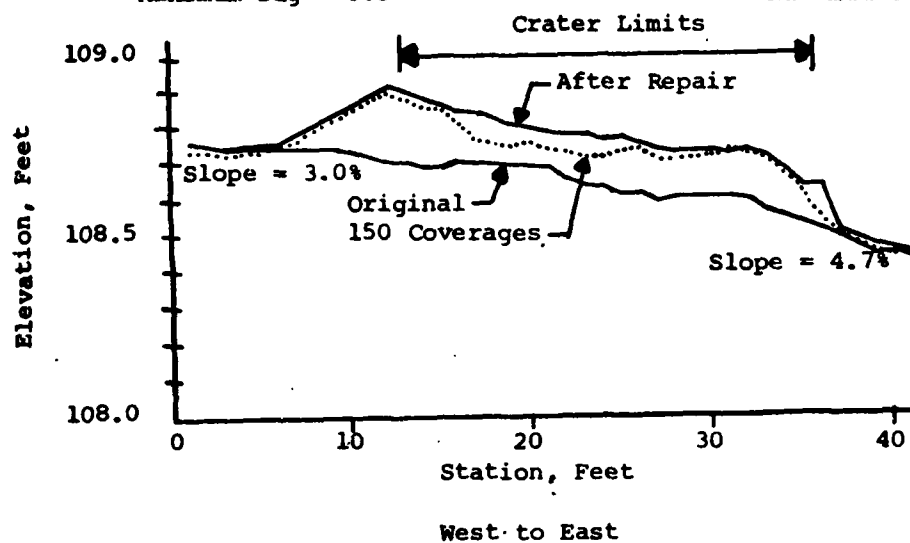
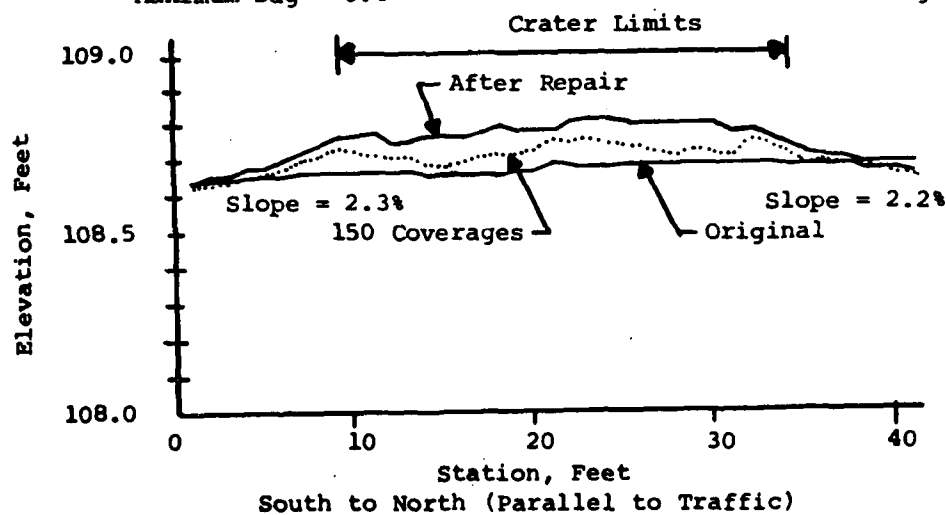
Figure 61. Crater 5 Profiles

After Repair: Maximum Upheaval = 2.5"    150 Coverages: Maximum Upheaval = 2.3"  
 Maximum Sag = 0.5"    Maximum Sag = 1.1"

After Repair: Maximum Upheaval = 1.7"    150 Coverages: Maximum Upheaval = 1.0"  
 Maximum Sag = 0.4"    Maximum Sag = 0.8"

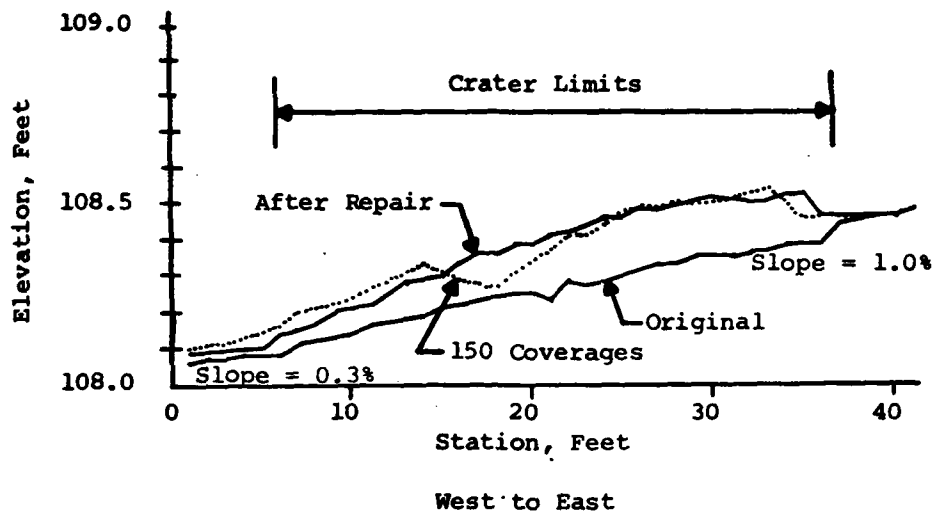
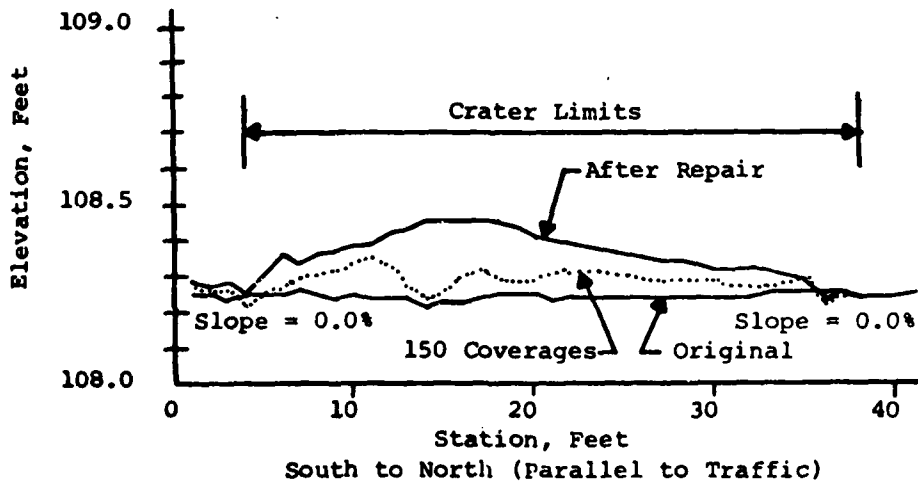
Figure 62. Crater 6 Profiles

After Repair: Maximum Upheaval = 2.2"    150 Coverages: Maximum Upheaval = 2.2"  
 Maximum Sag = 0.7"    Maximum Sag = 1.5"

After Repair: Maximum Upheaval = 2.8"    150 Coverages: Maximum Upheaval = 1.3"  
 Maximum Sag = 1.0"    Maximum Sag = 1.3"
